APPENDIX B

PHOTO LOG

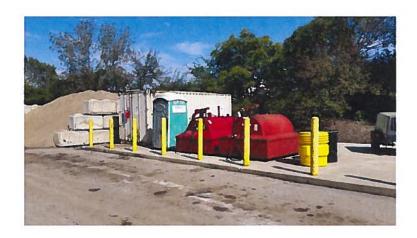
Photo #1

Description: Fueling station ASTs. Facing

east.

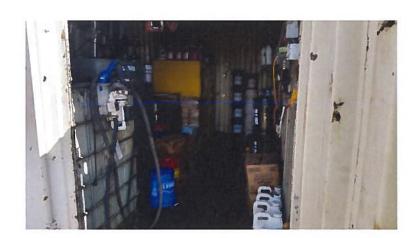
Photo #2

Description: Storage building at fueling

station. Facing east.

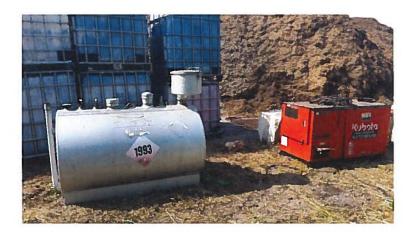
Photo #3

Description: AST fueling generator near

colorant area. Facing west.

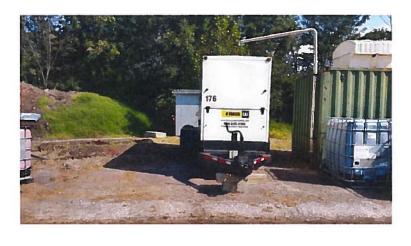
Photo #4

Description: Generator powering equipment at the colorant area. Facing east.

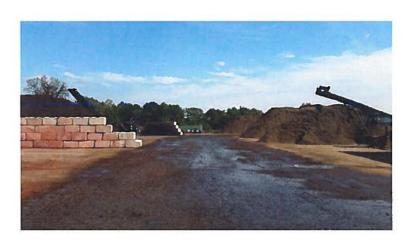
Photo #5

Description: Recently watered ground to control dust in the colorant area. Facing

east.

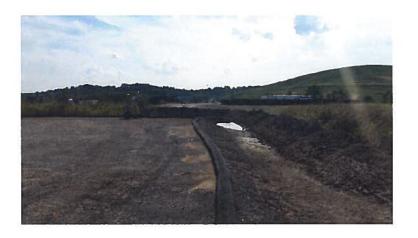
Photo #6

Description: New sedimentation pond at northwest corner of the Facility. Facing

south.

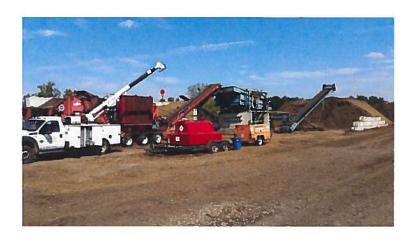
Photo #7

Description: AST in wood grinding area north end of the Facility. Facing east.

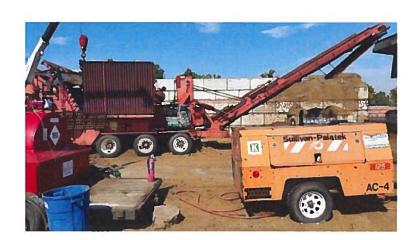
Photo #8

Description: Note fuel tank nozzle not stored properly and uncovered waste

receptacle. Facing north.

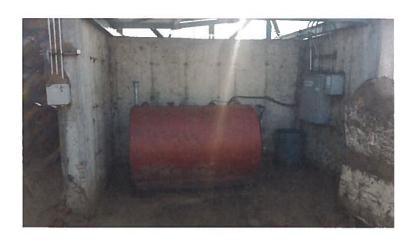
Photo #9

Description: AST in wood grinding area.

Facing south.

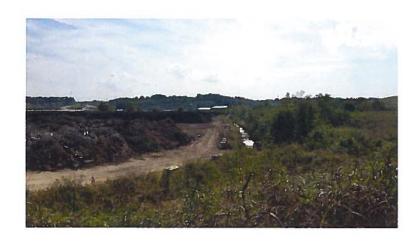
Photo #10

Description: View of wood storage, composting windrows and sedimentation

ditches. Facing south.

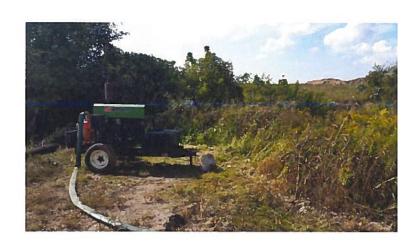
Photo #11

Description: Pump for moving water out of sedimentation ditches. Note two outfall

signs. Facing west.

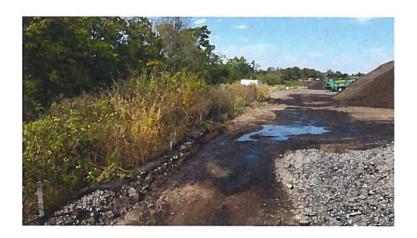
Photo #12

Description: Damage filter socks at southwest corner of the Facility. Facing

north.

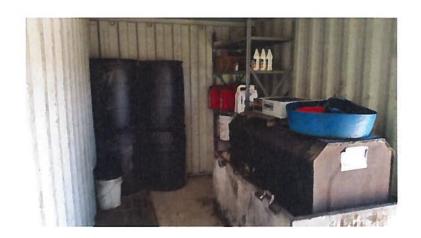
Photo #13

Description: Waste oil AST and small containers of petroleum products at

lubrication station. Facing south.

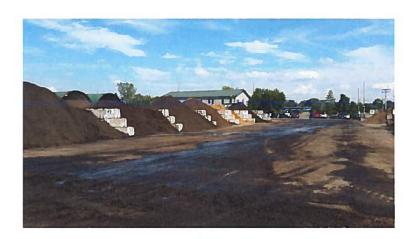
Photo #14

Description: Retail sales area. Facing

east.

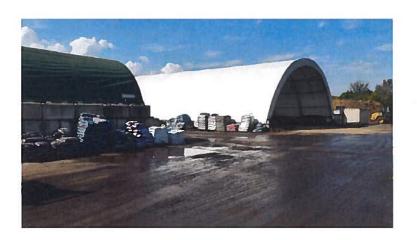
Photo #15

Description: Covered material area. Note water haul roads for dust control.

Facing north.
